# PROPERTY INSPECTION REPORT

Subject Property: 77 Dream Home Ct, New Braunfels, TX

Date of Inspection: 6/22/2024

Property Pulse Inspection Services LLC

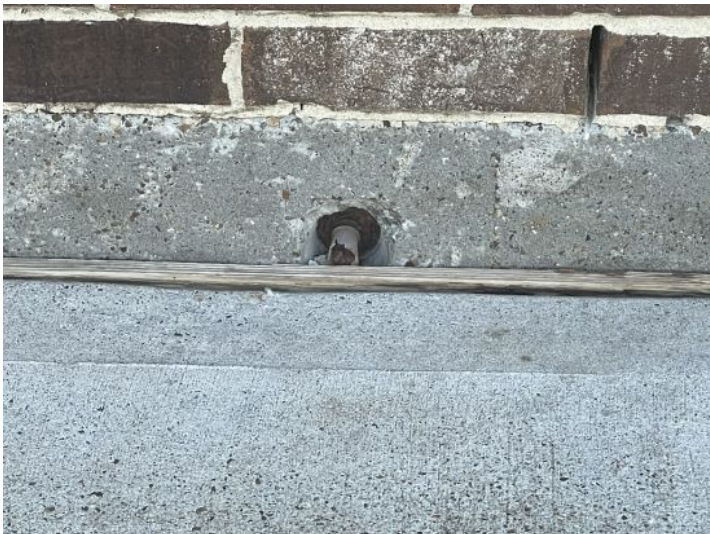
Exposed post-tension cable anchors at various locations

- Foundation Performance Opinion: The foundation appears to support the structure as intended. Recommend that the client consult with a specialist if there are any concerns.
- Observed corner cracks at various locations. These are typically cosmetic and do not affect the overall performance of the foundation or its ability to support the structure. The client may wish to have a foundation or masonry contractor evaluate these areas and repair them as recommended.
- Observed exposed post-tension cable ends at various locations. This exposes the anchor to moisture, eventually causing rust and deterioration of these components. Recommend repair by a qualified masonry contractor to remove any existing rust and seal these areas with mortar.

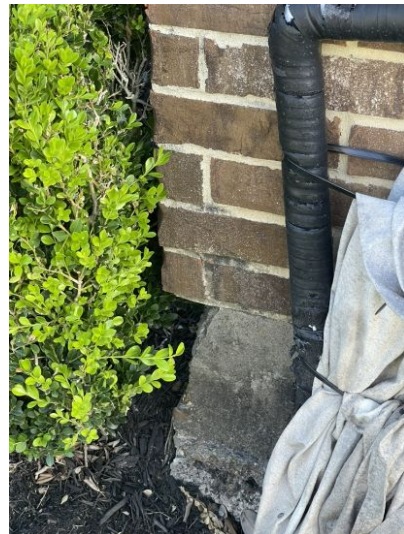
Corner cracks observed at various locations

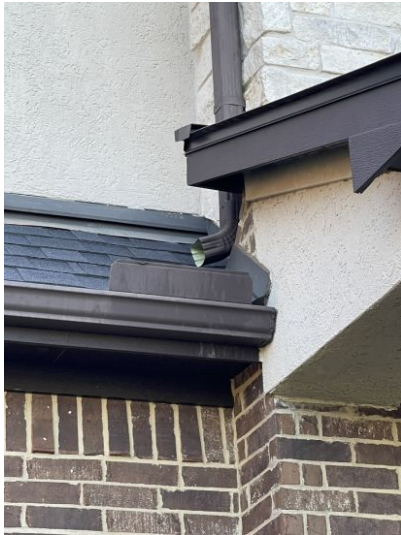
- The second story downspouts on the front of the home discharge onto the first floor roof coverings. This can cause premature wear of the roof coverings. Recommend extending the discharge points so that the downspouts empty into the first story gutters.

Downspouts discharging on roof covering. Recommend extending to discharge into first story gutters

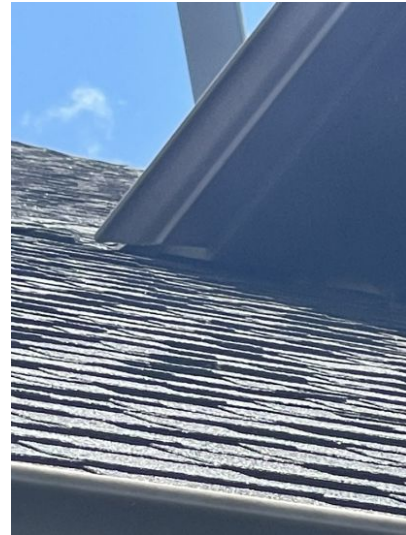
- At the rear of the home, the gutter for the second-story roof has an open end that allows water to discharge directly onto the first story roof surface. This could lead to premature deterioration of the roof covering and potential water intrusion under the shingles in that area. Recommend evaluation by a qualified contractor for potential remediation options.

Gutter discharging on roof covering. Recommend evaluation by a gutter contractor and remediation as recommended

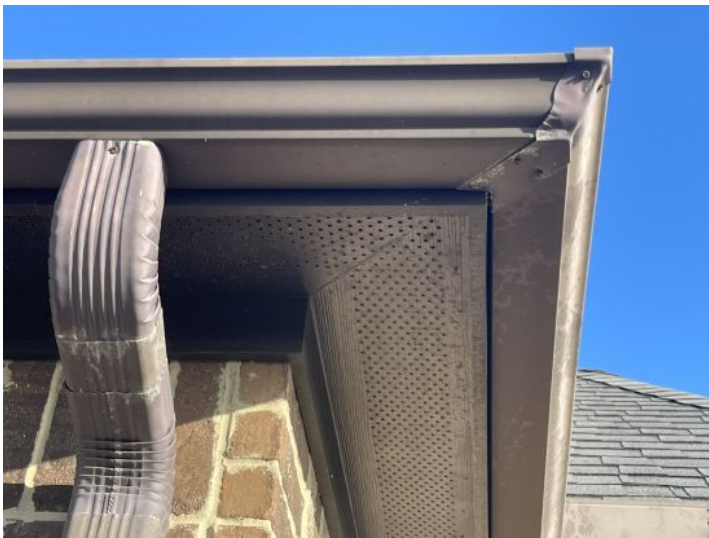
- Observed indications of leaks in gutter or downspout joints at various locations. Recommend evaluation by a qualified contractor and sealing/repair as necessary.

Leaking gutters and downspouts at various locations

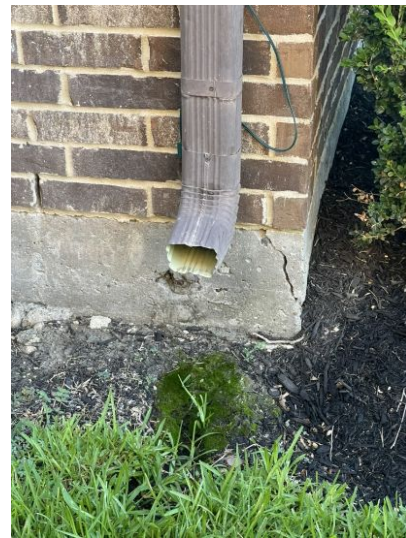
- Downspouts at various locations are improperly secured to walls or improperly terminated. Downspouts should extend 5 feet from the home and terminate in a splash block to prevent erosion. Recommend extension of existing downspout terminations or installation of splash blocks to prevent soil erosion.

Downspout terminating at foundation. Recommend extending 5 ft from foundation at a splash block

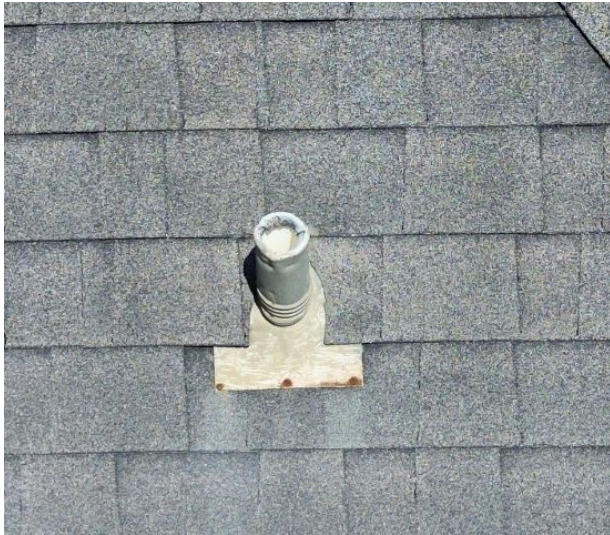
- Observed rusted and exposed flashing fasteners at one or more locations on the roof covering. Recommend working with a qualified roofing contractor to reseal fasteners with appropriate material.

Exposed fasteners at various flashing locations

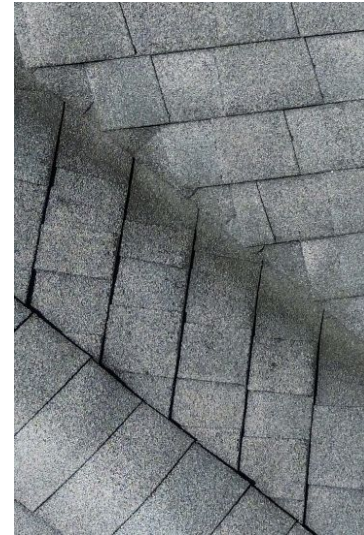
- At various locations on the roof covering, granule loss typical for a roof of this age in this climate were observed. The homeowner should have the roof covering evaluated by a qualified roofer and budget for replacement within the 3-5 years.

Representative granule loss at valley

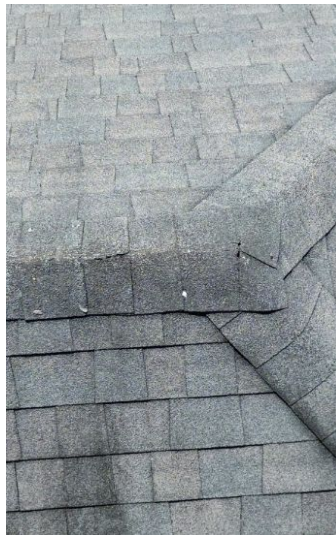
- Observed damaged and cracked ridge cap shingles in various areas on the roof. Although there are no indications of roof leaks at this time, they could eventually fail and allow water into the structure. Recommend working with a qualified roofing contractor to replace damaged shingles in these areas.

Damaged/split ridge cap shingles - various locations

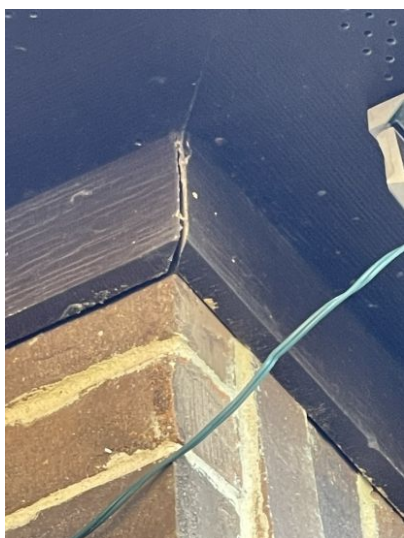
Open joints at frieze boards at various locations.  
Caulk/seal and monitor

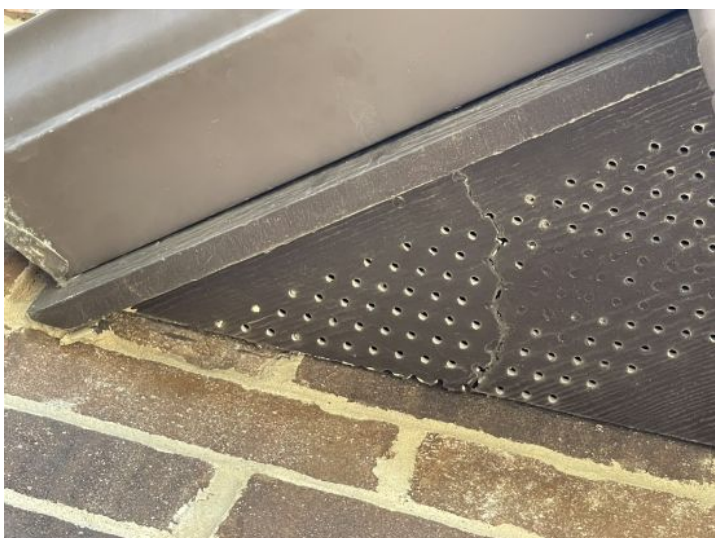
Cracked vent soffit. Monitor and repair if needed

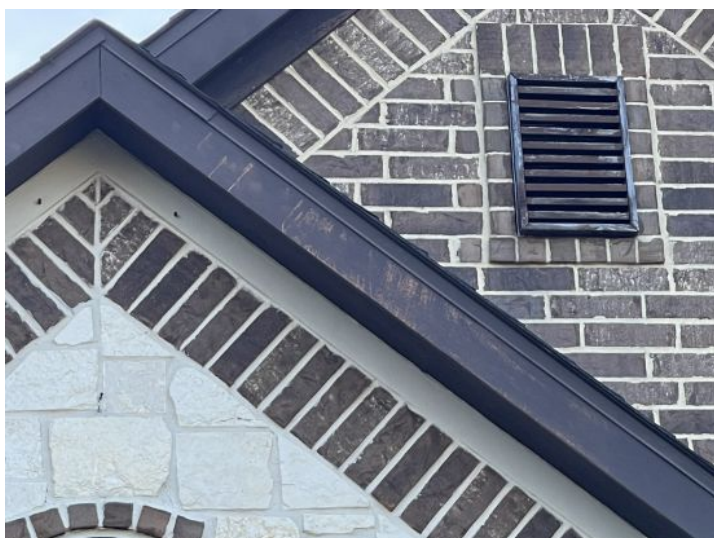
Damaged/weathered paint - soffit and fascia @  
various locations

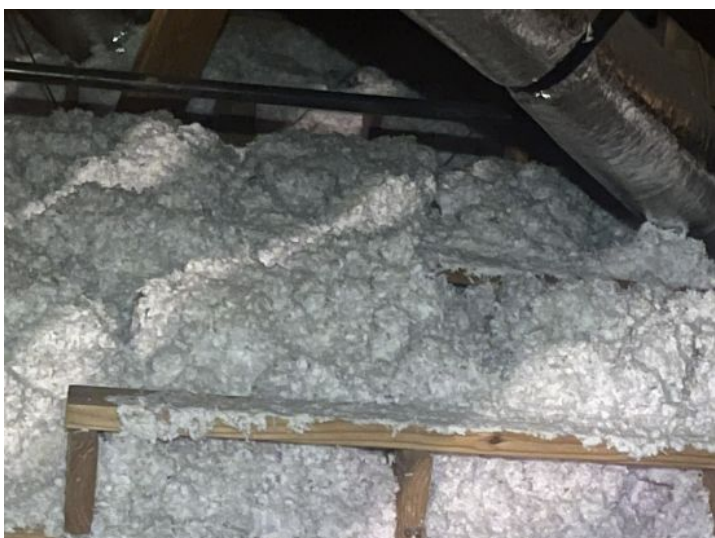
- There are visible indications of possible rodent activity in the attic. Recommend the client work with a pest control company to determine if this is an active or previous infestation, identify potential entry points, and take steps to prevent further activity and remove any contaminants.

Evidence of pest activity - tunnels and  
compressed insulation

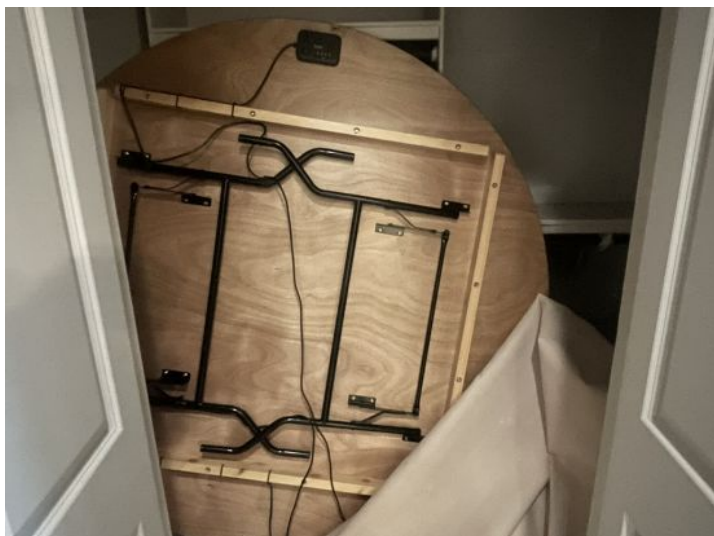
Inspection restrictions due to stored personal items - various locations

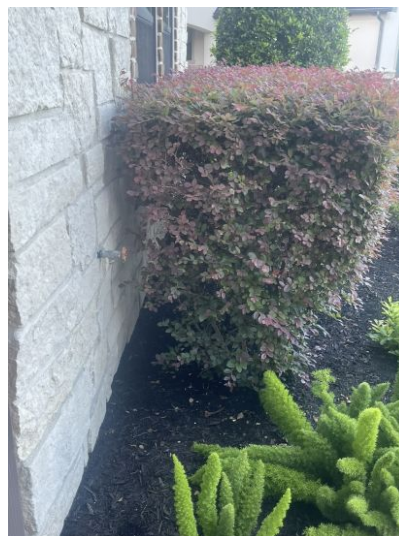
- At one or more locations, the view of exterior walls was obstructed by vegetation. Recommend trimming back any vegetation at least 1 foot away from the house to allow proper drying of stone work.

Vegetation close to wall/restricted inspection access. Recommend trimming vegetation at least 12" from wall

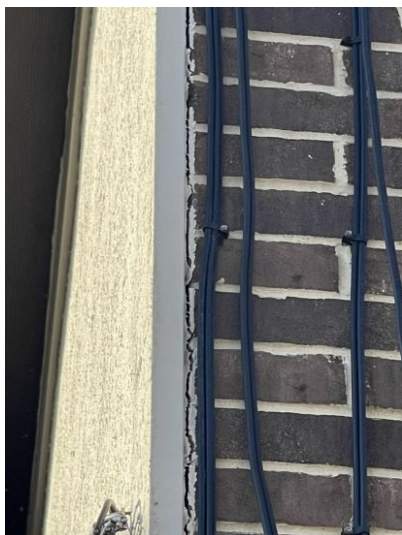
- At the second-story exterior wall, the joint between the stucco and brick veneer is deteriorated at various locations. Unsealed exterior joints could lead to moisture penetration. Recommend working with a qualified contractor to seal this with an appropriate exterior rated elastomeric sealant.

Open caulk joint - stucco to brick interface

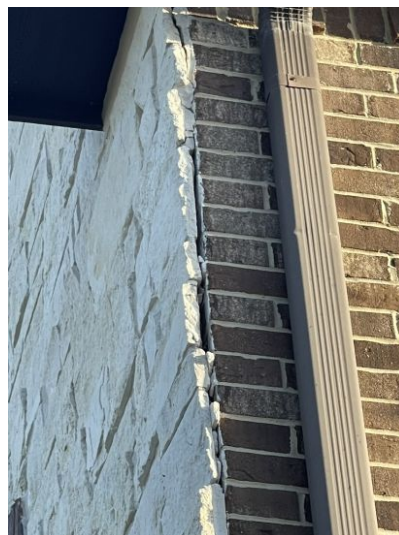
Cracks, open joint at stone veneer to brick veneer interface. Recommend repair by masonry contractor

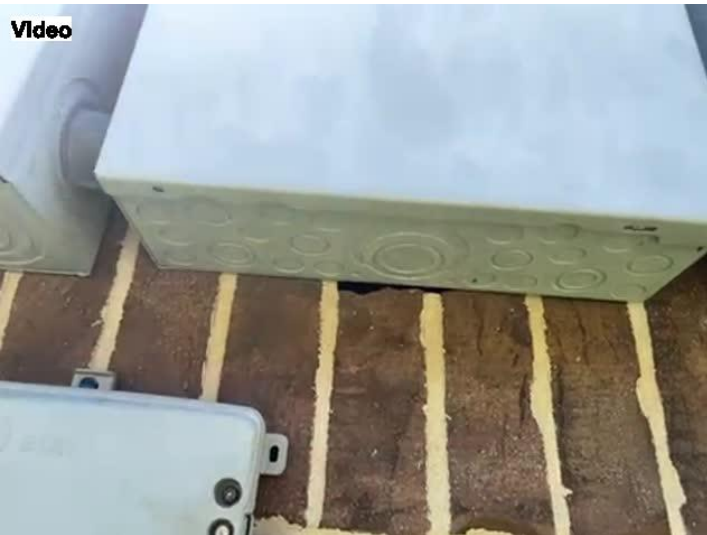
- Observed holes in the brick veneer underneath the service and sub-panels. It appears that the installer wasn't "precise" when installing the service panels and conductors. Recommend having a contractor or mason repair the holes to eliminate this is a potential location for moisture intrusion or pest entry.

Holes in brick veneer - electrical main and sub panel

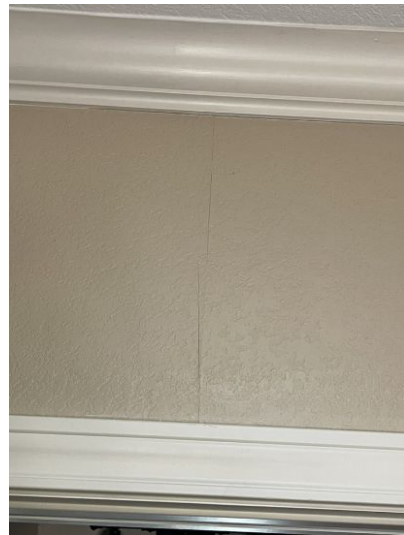
- FYI - noted minor cracks(s) in one or more drywall tape joints. Cracking in drywall or drywall joints is expected, as most houses will experience minor settling in the first few years after construction regardless of construction quality. In the inspector's opinion, this is purely cosmetic and not an indication of foundation movement. If the client has any concerns, it is recommended that they contact a qualified foundation contractor for further evaluation

tape joint crack - upstairs hall

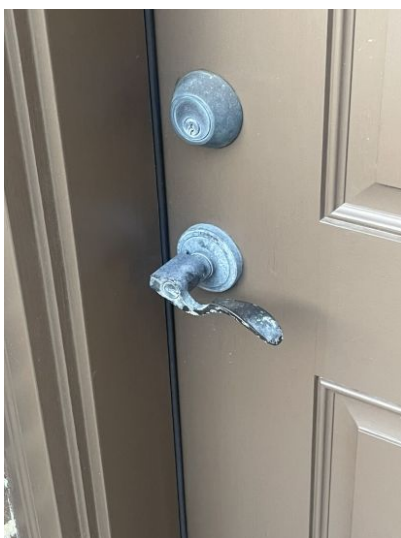
- At various locations, the inspector observed weathered or corroded door hardware. While this does not appear to impact functionality of door knobs or locks, the homeowner may want to consider replacing these in the near future.

Corroded door hardware - various locations

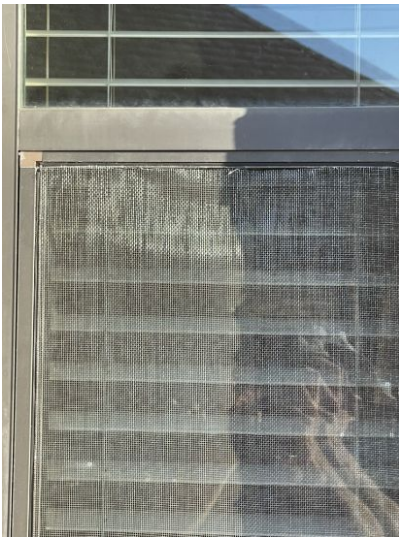
Damaged/weathered screens - various locations

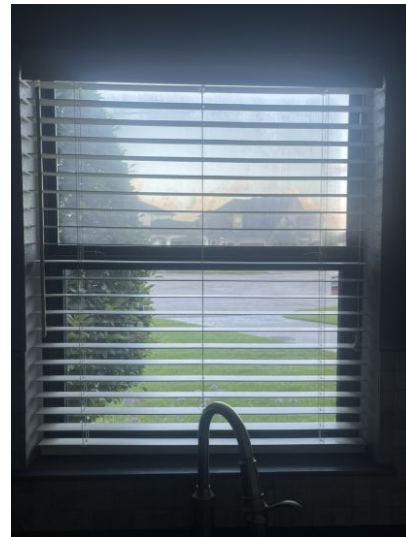
Fogged windows - various locations

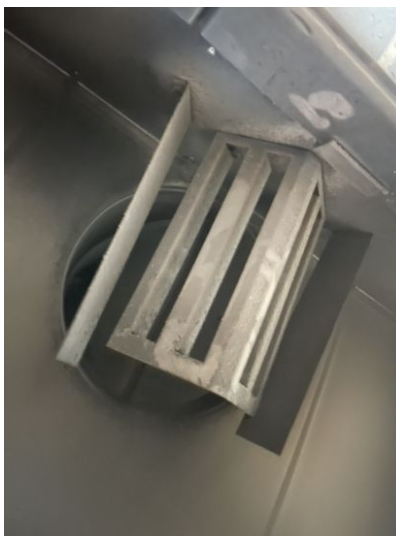
Fireplace flue - recommend installing a damper clamp

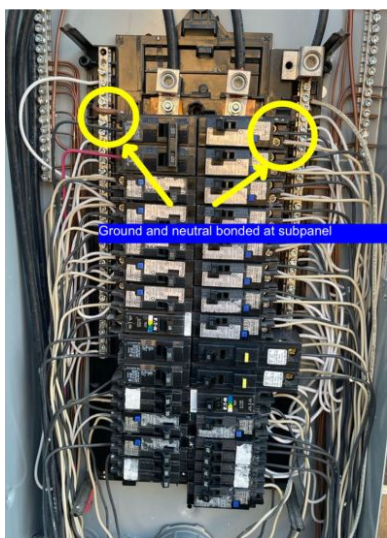
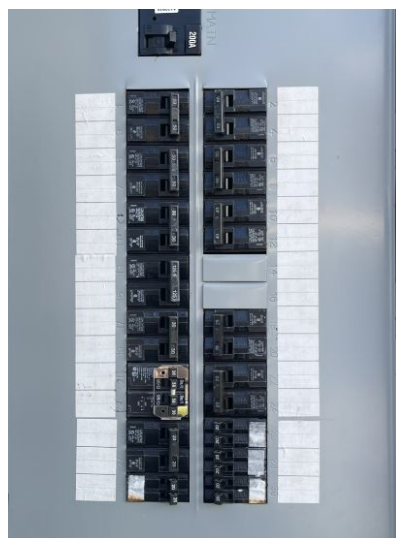
Branch circuits not labeled and main and sub-panels

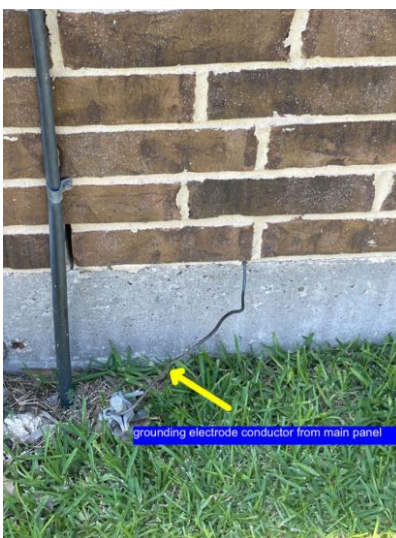
Grounding electrode conductor from main service panel. NOTE - only one electrode present. Recommend upgrade.

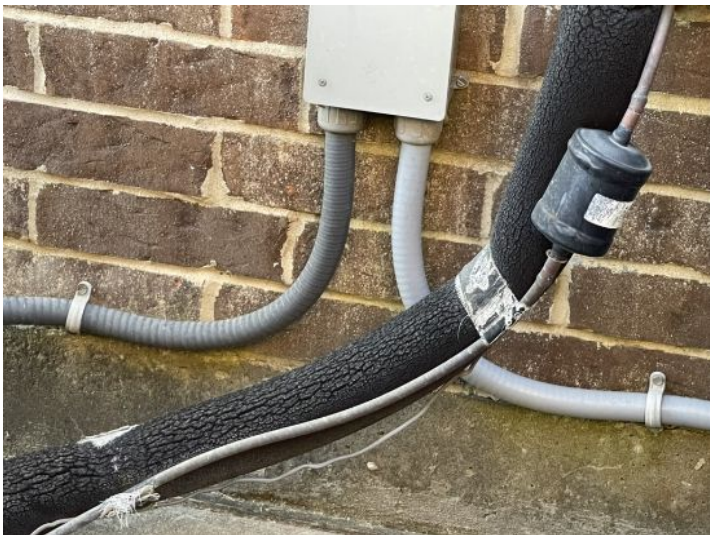
weather damaged insulation on HVAC return line. Replace insulation to maintain system efficiency.

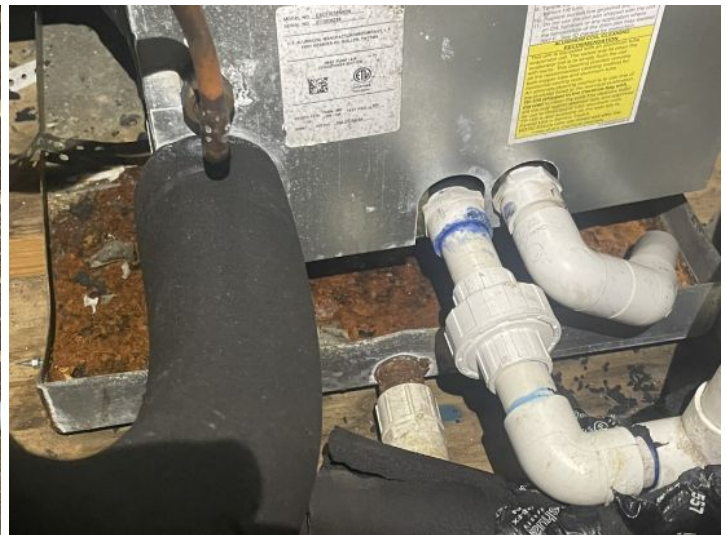
Rust and moisture present in secondary drain pans

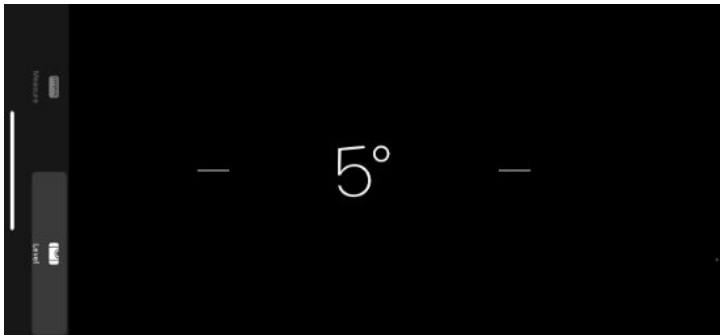
HVAC units out of level - recommend releveling the units

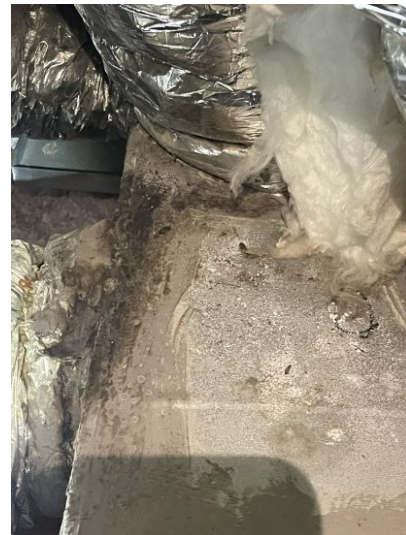
Possible organic growth on HVAC plenum and ducts

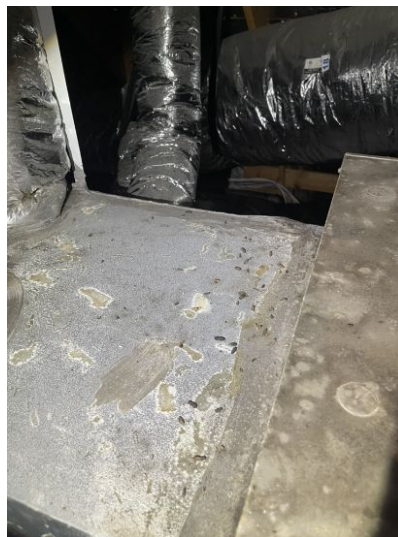
- There is evidence of suspected pest activity present on the air handler cabinets. Recommend evaluation by a licensed pest control technician to determine status of infestation (previous or active), along with taking appropriate actions to prevent future infestations.

indications of pest activity on HVAC cabinets

Also recommend that both HVAC systems be cleaned and serviced by a licensed HVAC contractor.

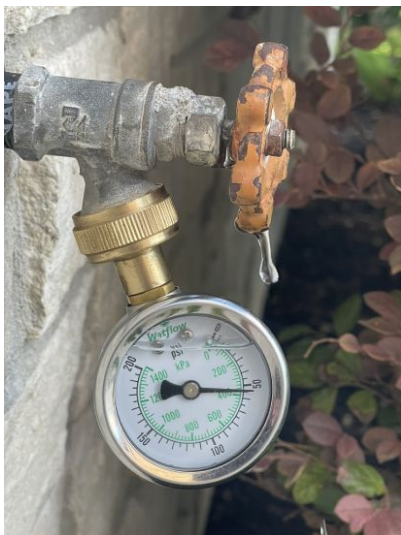
- At least one hose bibb is not equipped with an anti-siphon device. A possible cross-contamination can occur, which is a potential safety concern. A qualified plumber should install an anti-siphon/vacuum breaker.
- At least one hose bibb is leaking/dripping. Recommend engaging with a licensed plumber for repairs as needed.
- The water meter cover is loose, missing or damaged. Recommend reinstalling the cover to eliminate this safety/trip hazard. If the cover is damaged, contact the local utility for a replacement cover.

Water pressure of 55 PSI. Note leaking faucet and missing anti-siphon device

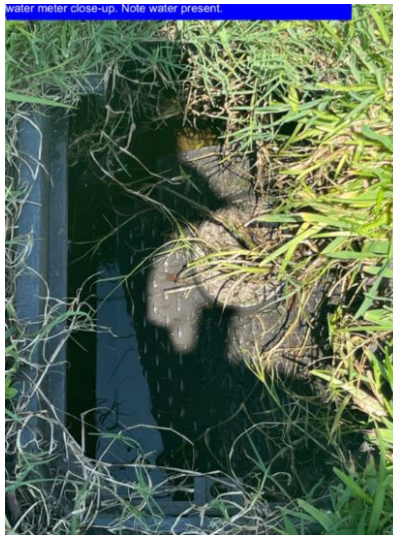
Water meter close up - note loose cover, water standing in meter box due to recent rains

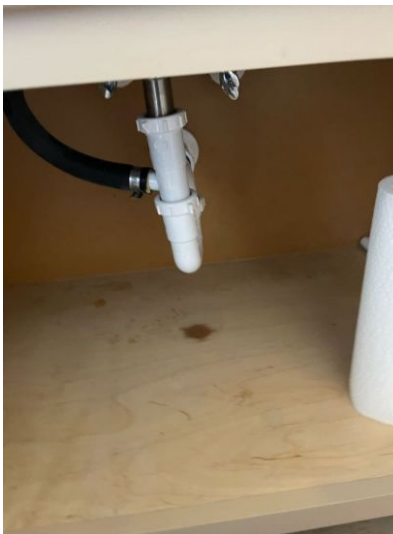
- The sink drain in the upstairs bath 1 is leaking and water was observed in the cabinet. Recommend evaluation by a license qualified professional and repair as necessary.

Leak at sink drain - upstairs bath 1

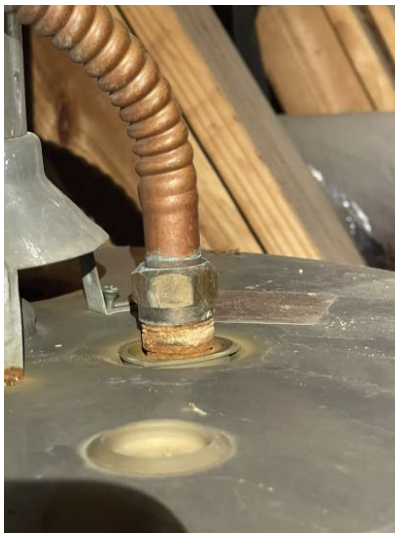
- The average life expectancy for a water heater is 8-12 years. Recommend budgeting for replacement.
- Water inlet and outlet pipes are heavily corroded. If left unchecked this could result in water leaks and damage to the water heater or property. Recommend engaging with a licensed plumber for evaluation and repair as necessary.

Corroded inlet and outlet pipes at water heaters. Recommend replacing corroded fittings

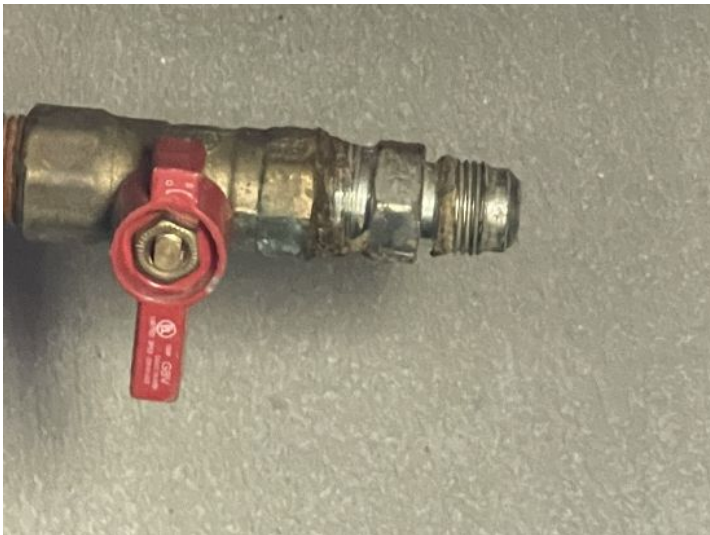
Missing caps at one or more unused gas valves. Cap with approved materials

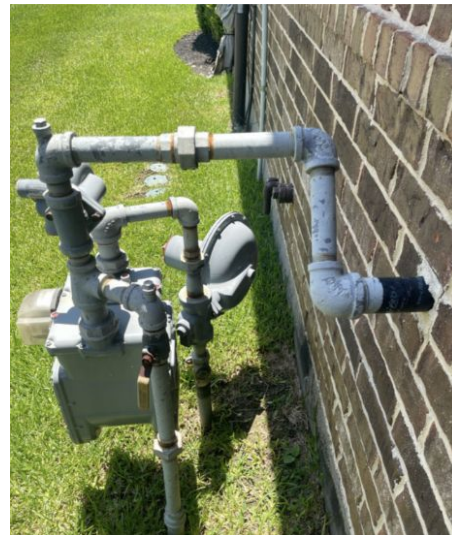
- The gas meter assembly does not appear to be properly bonded to the electrical system. Recommend evaluation and remediation by a licensed electrician
- Under the countertop of the outdoor kitchen on the back porch, an unused natural gas supply line is uncapped, and the inspector noted a slight odor of gas in that area during the inspection. This is a potential fire/safety hazard. Recommend capping this supply line with an appropriately rated cap to prevent potential gas leaks

No bonding present at gas meter assembly. Work with a licensed electrician to bond the assembly to the electrical system.
