# PROPERTY INSPECTION REPORT

Subject Property: 77 Dream Home Ct, New Braunfels, TX

Date of Inspection: 6/22/2024

Property Pulse Inspection Services LLC

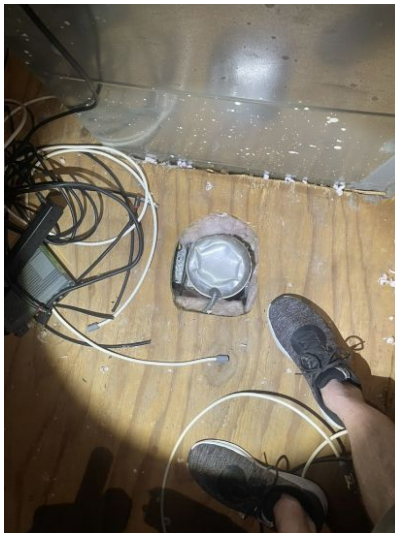
- The garbage disposal and dishwasher are not on GFCI protected circuits. Although this may not have been a requirement at the time of construction, we recommend that the homeowner consider this a possible safety upgrade.
- The housing for the recessed can light at the top of the second floor attic stairs is partially crushed. The light itself appears to be functional, however recommend further evaluation of the fixture and modification of the decking to prevent additional damage.

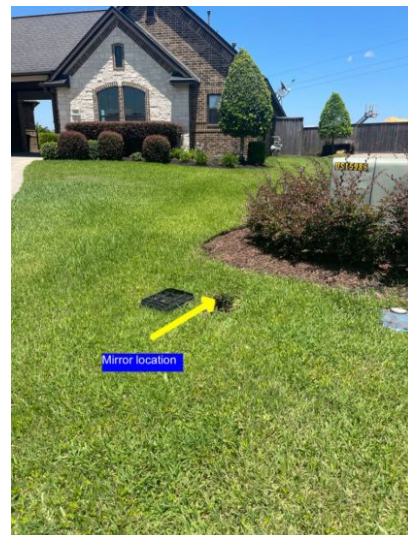
Water meter location - right of driveway near street

Water pressure of 55 PSI. Note leaking faucet and missing anti-siphon device
